All About Homes, LLC  
Michelle M. Teague  
Owner  
312-371-7414 Phone  
773-508-6209 Fax  
[www.allabouthomeschicago.com](http://www.allabouthomeschicago.com)  
[michelle@allabouthomeschicago.com](mailto:michelle@allabouthomeschicago.com)  
1725 W. Granville Ave.  
Chicago, IL 60660  
License # 450.0001071

Client Information: Record Number 20091103b

Inspected 11/3/09 1:00 PM

# Inspection Summary

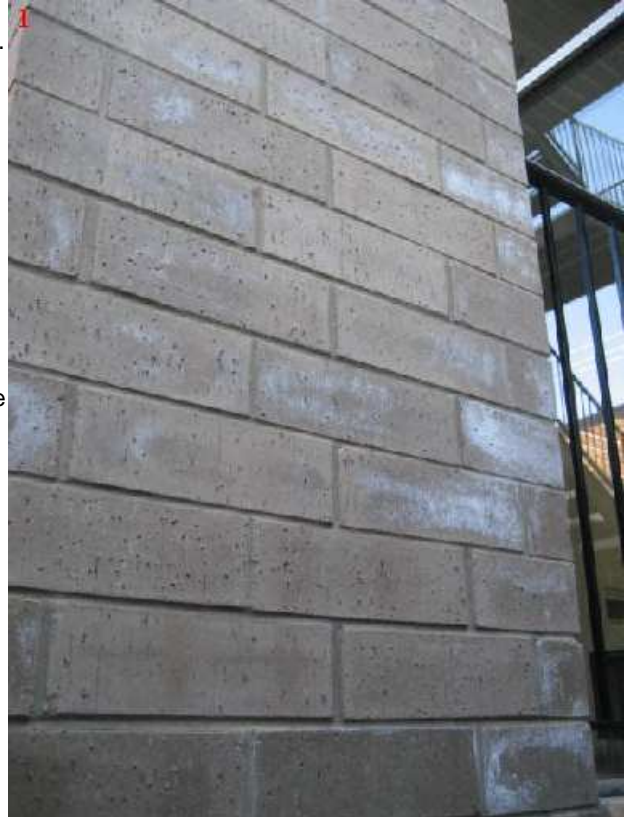
### Service/Repair Masonry Walls - Brk Veneer

- The lintels need another coat of paint to prevent them from rusting. Scrape and remove existing rust, then re-paint.
- Efflorescence (white mineral deposit that occurs when masonry products and water mix) is noted throughout the brick walls and columns. In a new construction building we cannot determine if this is because too much water is getting into the masonry due to construction problems or if it is because the bricks were wet on the construction site and are now drying out. We recommend a light acid wash to remove the existing efflorescence. Then monitor the building for development of new efflorescence. Photo shows example.
- Repair the broken masonry around the SW corner water spigot head.
- Remove the spray paint on the bricks in the NE corner of the home on the east wall.

Consult with a qualified mason to address the following issues:

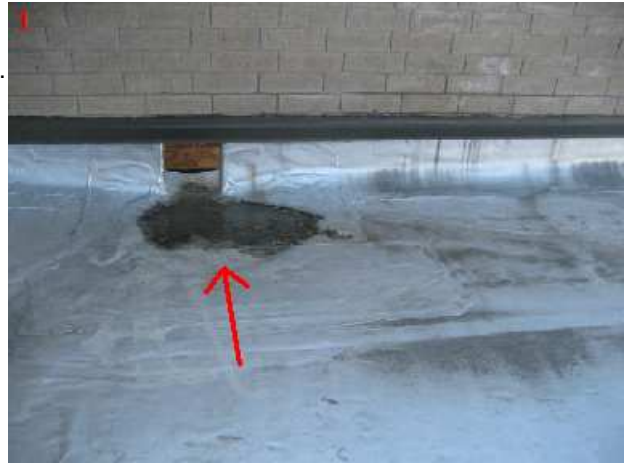
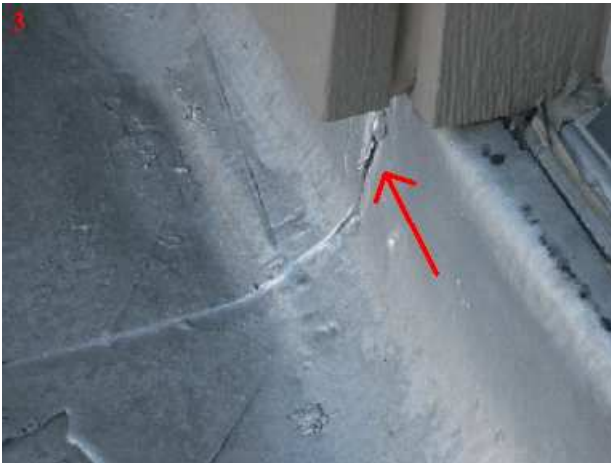
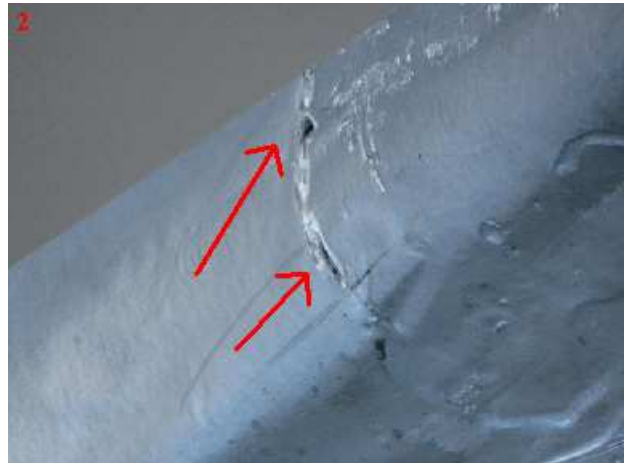
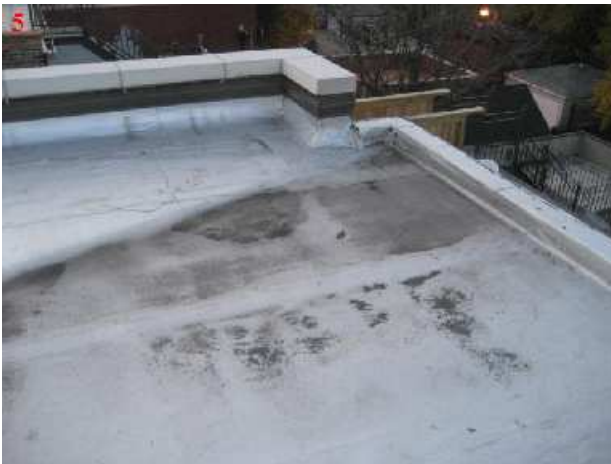
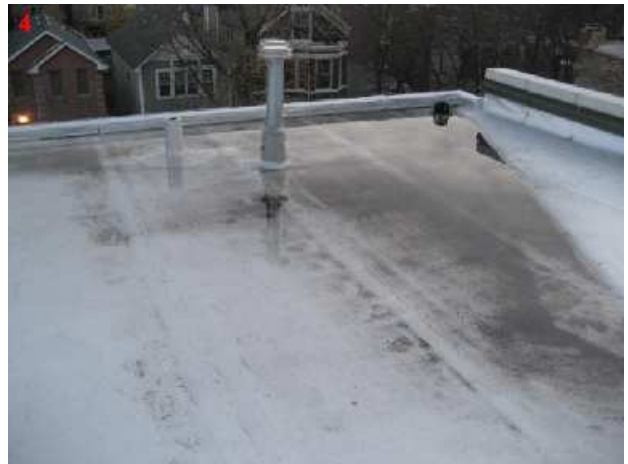
### Service/Repair Condition - Repair seams

- Re-seal all gaps in the seams on the roof (photos show examples). During the freeze/thaw cycle, water will get trapped in these gaps and will eventually cause leaking in these areas. Photos 2/3
- Water is ponding in front of the scupper on the back roof deck. Re-pitch this area so that water drains completely into the scupper. Photo 1
- Recommend rolling the roofing material into all scuppers and around the edges of the drain area as opposed to terminating the material at the edge of the scuppers.
- There is a significant amount of ponding water on the top section of the roof (photos 4/5). Re-pitch this roof so that water drains completely into the drain.

Please consult with a qualified roofer to address the following issues:

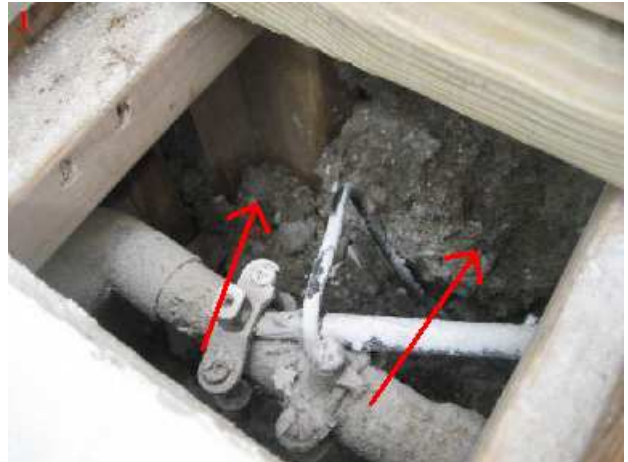
- The SE corner of the basement is visible water damaged. The drywall is wet starting at the base of the windows and then down to the foundation. The wall studs and insulation are visibly wet in the water meter access panel. There are also drip marks on the metal window frame above the wet drywall. We cannot determine if the water is coming from the somewhere above the base of the window or from the base of the window. Further evaluation is needed. Photos 1-2

The perimeter walls were spot checked with a moisture meter in the basement. Four areas were found with high moisture concentrations. We recommend that all drywall and insulation be removed in these areas and replaced once the source of the moisture is located. All electrical outlets/facilities in these areas should also be checked for corrosion/moisture damage.
