Inspection Report

**Vintage single family home example
Chicago IL**

All About Homes, LLC

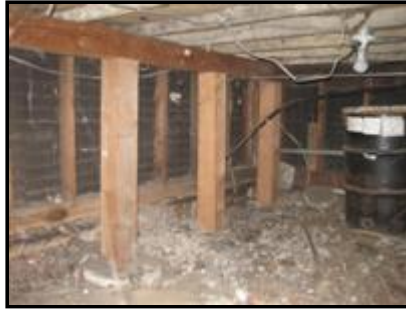
E. Picture 1

(2) There is an old chemical storage drum under the back porch. Remove this drum according to proper disposal requirements for the type of material it holds/held.

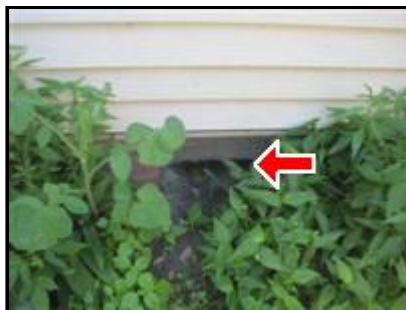
E. Picture 3

(4) The land under the enclosed back porch area is dirt. Expect this area to be damp and humid. This can attract creatures and wood boring insects as well as lead to mold growth. Consider either adding a vapor barrier over the dirt and/or venting this area to help improve air flow (after more insulation is added).

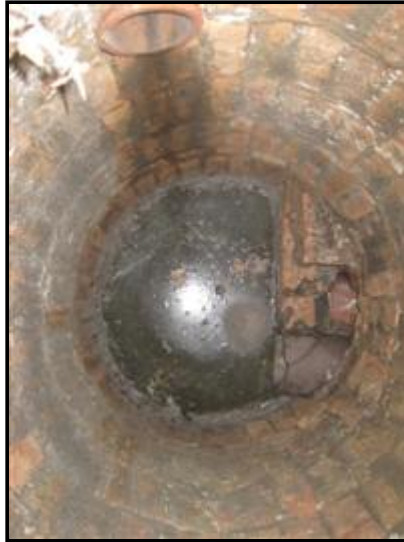
M. Picture 1

(2) The drain line in the catch basin no longer has a trap. This will allow debris in the basin to run through the drain line. We recommend adding a trap on this drain line. Consult with a qualified plumber to install a trap.

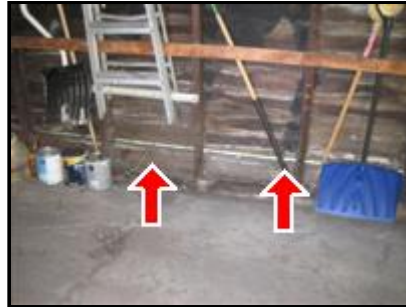
The garage siding is older and in need of repair or replacement. The wood is deteriorating and there are many gaps in the siding that are allowing water into the garage. Consult with a qualified siding contractor to determine if it will be less expensive to install new siding or restore the existing siding.

B. Picture 1 Gaps in siding

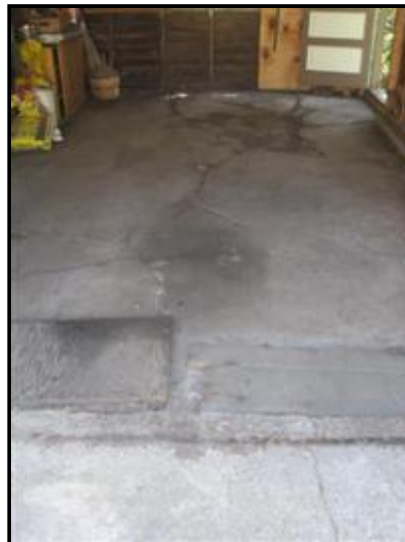
K. Picture 1

The garage slab is in very poor condition. The only real way to address the cracking and settling is to remove the existing concrete and pour a new slab. If the slab is to be replaced it will likely be cheaper to tear down the garage and rebuild then to try and repair all the other items in this section.

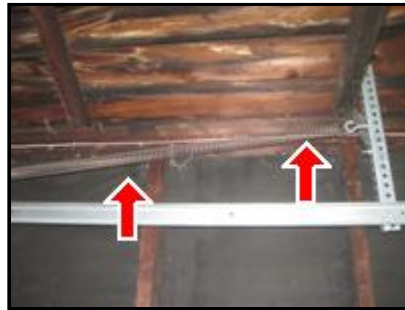
L. Picture 1

🏠 (2) The springs for the garage door need safety cables installed. Safety cables are metal wires that run through the middle of the springs and attach at the ends. If the spring breaks and safety cables are installed then the springs cannot damage anyone or anything in the garage. Install safety cables.

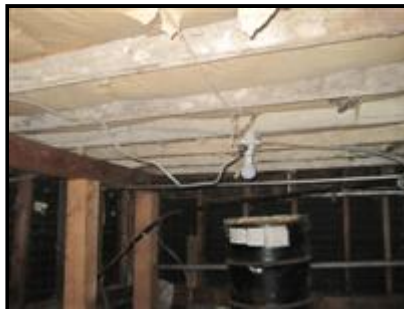
I. Picture 1

🏠 (3) The wiring under the back porch is in poor condition. Consult with a qualified electrician to add properly grounded circuits that run in solid metal conduit. Romex should not be used and wiring should not run out of light fixtures. See photo

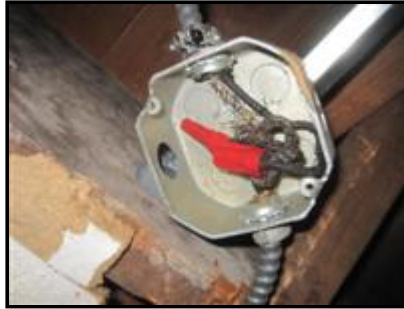
J. Picture 1

🏠 (1) Add covers over all exposed wiring throughout the home. All switch boxes, outlets and junction boxes should be covered so that no wiring is exposed.

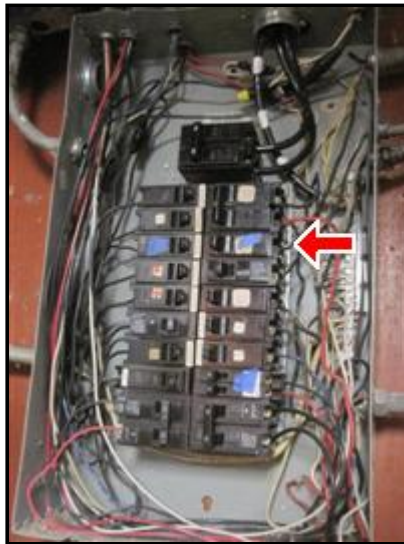
J. Picture 2

🏠 (2) Aluminum branch wiring was noted inside the electrical panel - 1 circuit on right side, 3rd breaker down. Aluminum wiring should not be used on the branches that run through the walls to switches, outlets and fixtures because it can overheat. Consult with a qualified electrician to remove all aluminum branch wiring.

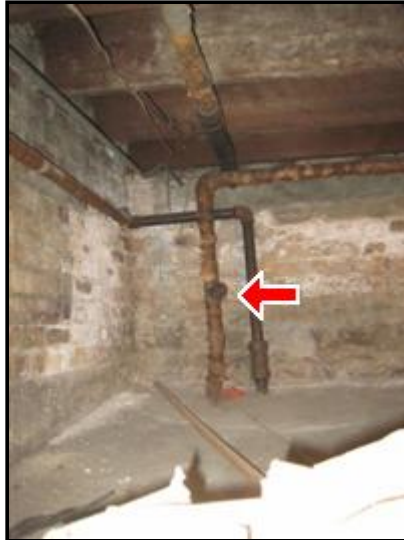
C. Picture 1

The water main and much of the supply piping is 'insulated' with newspaper. We recommend removing this insulation so the pipes can be inspected. Replace the insulation with foam.

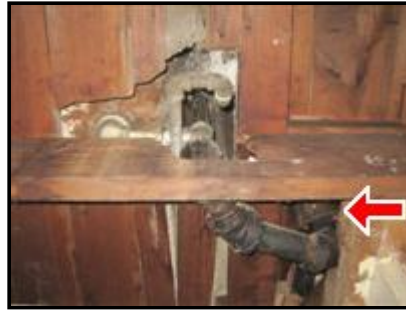
E. Picture 1

(2) Drum traps are present on the bathroom drains. These are common in older homes but can lead to slow drainage. Additionally, they need to be cleaned periodically which can be a messy under

taking. Recommend consulting with a qualified plumber to replace the drum traps with modern P-traps.

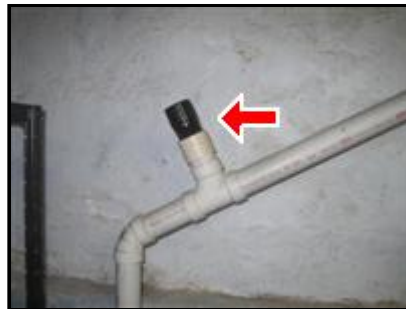
F. Picture 1

The kitchen drain does not appear to be properly vented in the main kitchen stack. A vent has been added on the line that releases into the basement. Why was this done? Consult with a qualified plumber to evaluate and repair as necessary.

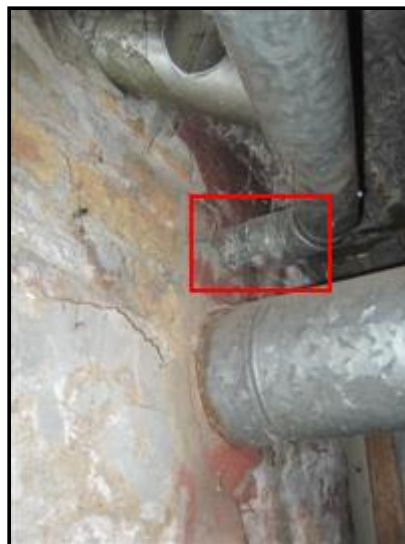
K. Picture 1

The water heater flue should increase at least 1/4 inch per foot. This flue turns downwards where it enters the chimney. This can lead to improper drafting. Consult with a qualified plumber to properly pitch this flue.

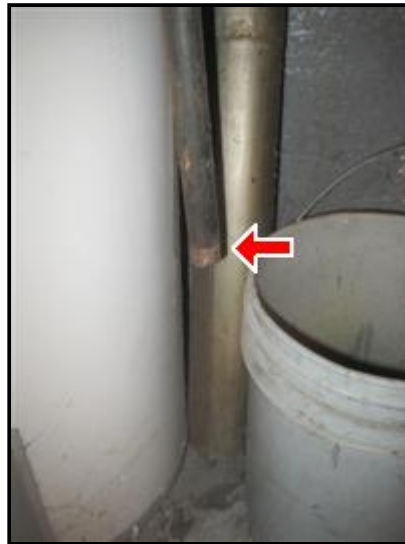
O. Picture 1

Temperature Pressure Relief Valve: Threading on extension
The extension pipe on the temperature pressure relief valve has threading on the bottom edge. This is not recommended because a cap could be screwed onto the bottom of this pipe. Covering this pipe could cause the water heater to explode in a high-pressure situation. Replace the extension pipe with a non-threaded pipe.

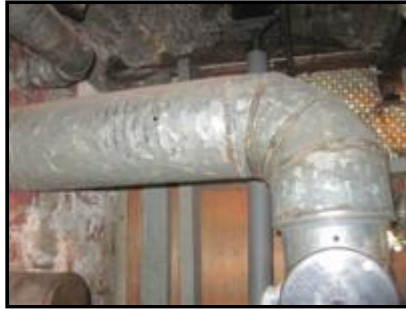
G. Picture 1

The boiler flue is corroded. This can be a sign that the flue is not drafting properly. This should be further evaluated by a licensed plumber or HVAC contractor at the tune up. It is possible that this corrosion occurred before the chimney liner was installed.

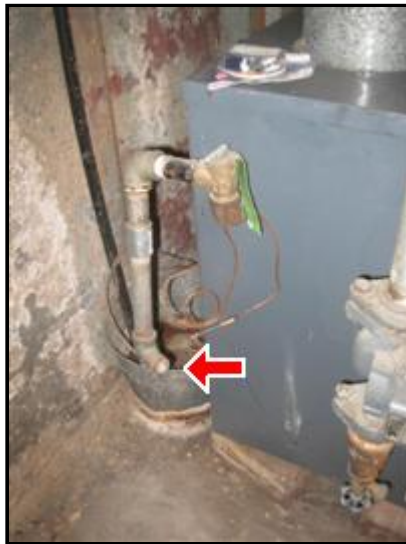
K. Picture 1

The pipe extension that should run from the temperature pressure relief valve to the floor is too short and it bends so that water could be released onto people. Please extend this pipe so that it is no more than 6 inches from the ground and it is a straight pipe. If there is a near-by floor drain or drip pan, then the pipe should be extended into one of these facilities.

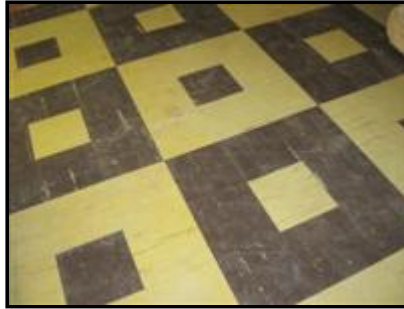
B. Picture 1

(1) The floor tiling in the basement may contain asbestos. Please consult with a qualified environmental testing company to determine if these tiles contain asbestos. Asbestos floor tiling was common in the 1940's and 50's. Most asbestos floor tiles are either of a 9x9 or 12x12 size. Typical protocol requires either covering the floor tiles (without nailing into them) or removing them. Follow all federal laws when removing or handling asbestos materials.

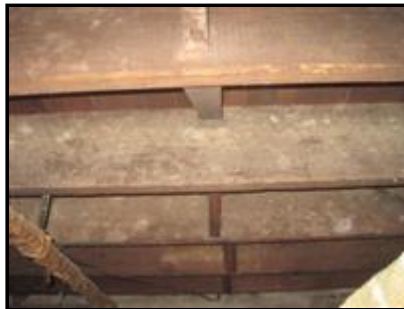
B. Picture 2

(2) A small amount of a possible mold-like substance was visible on some ceiling joists. This is likely from ongoing high humidity levels due to poor ventilation and foundation seepage. Consult with a qualified mold remediation contractor to determine the best way to manage this substance.

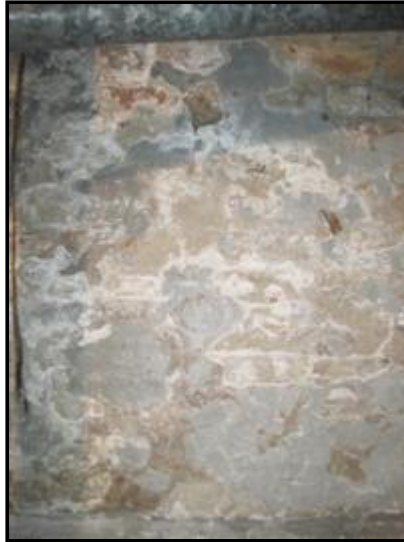
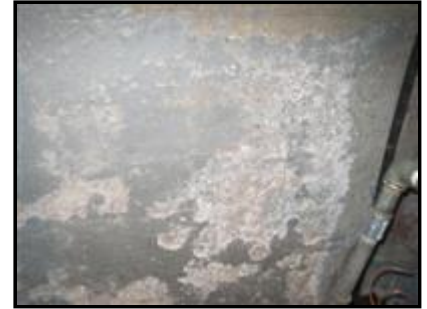
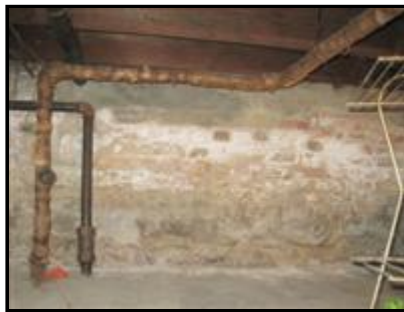
It is very common for there to be evidence of seepage in old foundation walls. Seepage generally occurs because of poor exterior grading and foundation deterioration. The presence of efflorescence on the walls (white mineral deposits) is an indication of ongoing seepage. We do not recommend finishing basement walls where seepage is occurring because the moisture can cause mold growth on wall board. Consult with a qualified basement water proofing contractor to determine the best ways to reduce seepage for this property. Photos show examples of heavy seepage on the south and west walls. We could not see the east wall because of the wall finishes.

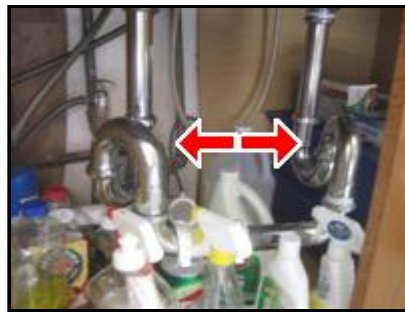
M. Picture 1

Both sink drains have S-traps instead of P-traps. S-traps can allow sewer gas into the home. Consult with a qualified plumber to replace the S-traps.

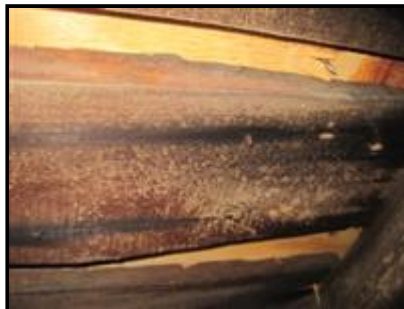
C. Picture 1

There is a significant amount of a mold-like substance present throughout the attic sheathing. This type of growth can occur because of ice damming in the winter and/or high humidity levels in the summer. See notes in the Insulation and Ventilation Sections for more information regarding ice damming and moisture levels in attics. Once all moisture related issues are resolved in the attic, consult with a qualified mold remediation contractor to address the existing substance throughout the attic space.

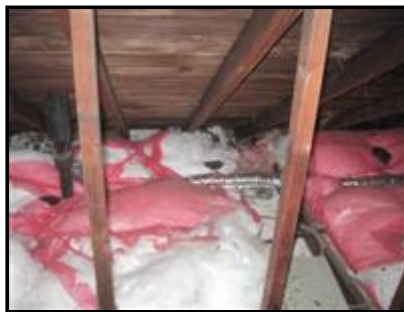
The ventilation in this home does not appear to be sufficient because the soffit vents are blocked. Consult with a qualified contractor to add baffles so that air can flow through the soffit vents. Also be sure to use the fan in the summer. (Picture 1)

F. Picture 1 Insulation in soffit vents
