Inspection Report

Townhome Example Chicago IL

Property Inspected
Townhome Example
Chicago IL

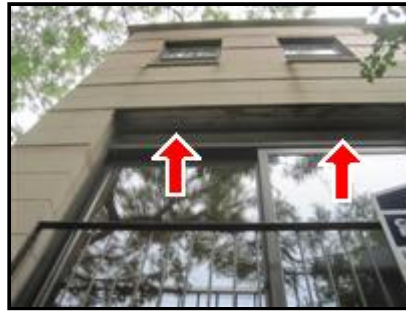
B. Picture 1

Masonry/Stucco: Brick Veneer, Rusting lintels

The structural steel lintels above the juliet balcony doors are rusting. The rust will cause the lintels to expand and push on the masonry. This will cause step cracks to occur in the bricks. Scrape/ remove the rust from the lintels and re-paint them with an appropriate exterior paint in order to prevent further rusting. This is likely an association issue. Are there plans to work on the lintels?

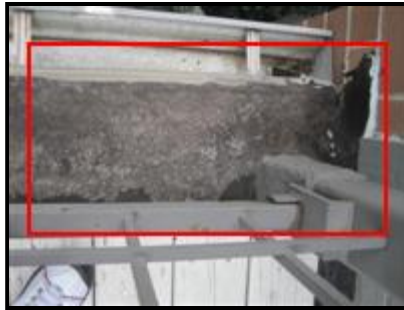
C. Picture 1

SAT	SIG	SAF	RR	MIN	DM	QU	NIV	NP	Items
<input checked="" type="checkbox"/>									A. Gutters Gutters: Aluminum
<input checked="" type="checkbox"/>									B. Downspouts Downspouts: Aluminum
					<input checked="" type="checkbox"/>	<input checked="" type="checkbox"/>			C. Roof Condition How Inspected Roof/Gutters/Downspouts: Walked roof, From deck/porch/balcony Extent View of Roof/Gutters/Downspouts: Covered by decking Roof Style: Flat, Shed Roofing Material: Architectural asphalt/fiberglass, Modified bitumen Roof Condition: Alligatoring <input checked="" type="checkbox"/> (1) The roofing membrane that we could see along the sides of the roof deck is alligatoring. This is indicated by a series of fine lines and cracks in the membrane and it is an indication that the roof is reaching the end of its useful life. When roofing material begins to alligator expect cracking that can lead to leaking.

Is this roof considered a common element or is this covered by the association? Are there plans for the association to replace this roof? If so, how will the work be paid for?

If this roof is the responsibility of the home owner, then expect to replace this roof at any time. The deck will have to be removed and rebuilt when the roof is replaced.

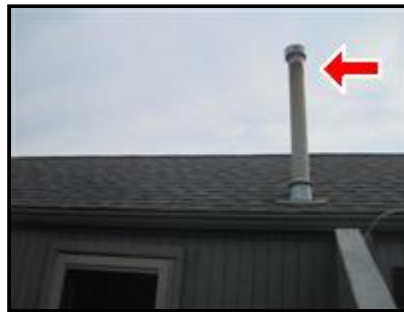
C. Picture 1

Chimney Chase: Metal Flue Pipe, Rusting

The metal flue piping is rusting above the roof line. Seal with an anti-rusting agent.

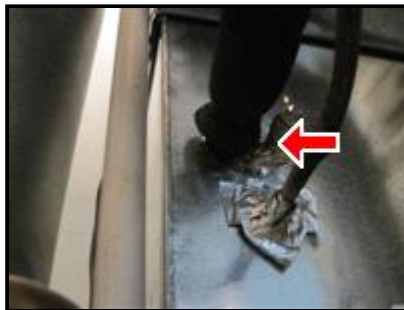
B. Picture 1

Fluid Line Condition: Caulk where lines enter wall of home, Needs new insulation - interior, Extend insulation all the way to coil cabinet

(1) The insulation on the AC fluid lines should be replaced at the coil. AC line insulation helps prevent condensation and improves the efficiency of the system.

(2) The AC fluid lines are insulated near the AC coil so that condensation does not form on these lines while the system is running. The insulation is incomplete near the coil cabinet. As a result, condensation will form and drip onto the mechanical equipment below. Add proper HVAC tape or putty to seal the lines and prevent condensation.

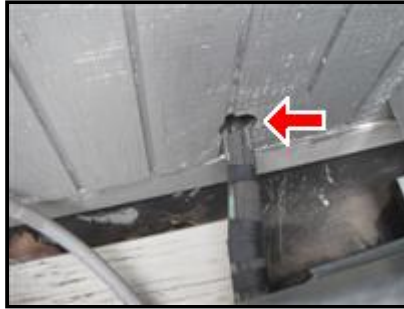
B. Picture 2

(3) Caulking is needed where the AC lines enter the wall of the home. This caulking will prevent moisture and critters from entering the home at the AC lines.

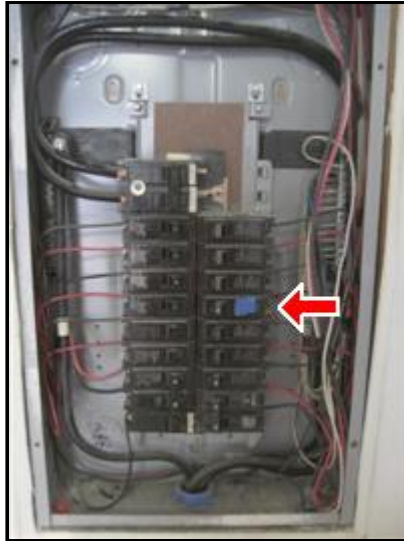
J. Picture 1

Double-tapping was noted in the electrical panel. One double-tapped breakers was present. Double-tapping means that two circuits are running into one breaker. This is a safety concern because the circuits can overheat and because wires in the panel can become loose. Consult with a qualified electrician to determine the best way to remove all double-taps.

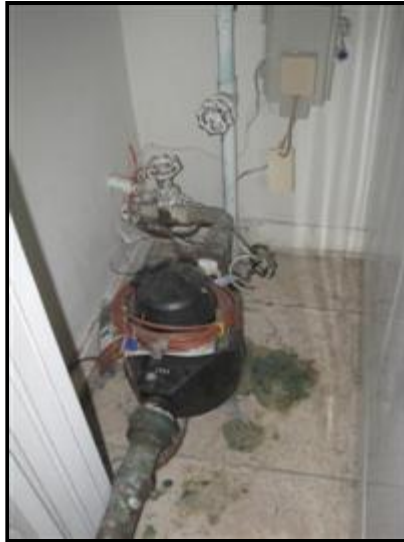
C. Picture 1

Main Water Shut-off Location: Laundry room

We recommend adding insulation on the water main pipe in the closet. This will prevent the pipe from sweating in the spring and fall.

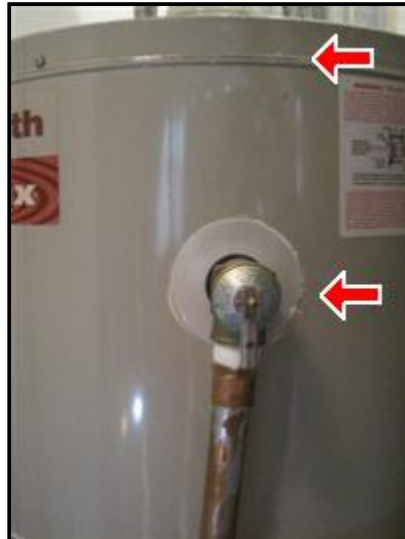
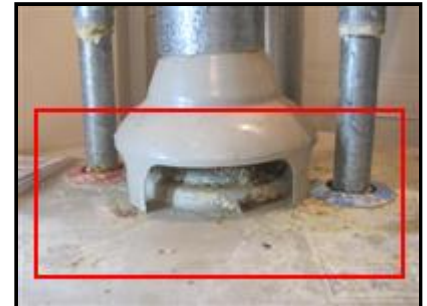
I. Picture 1

Water Heater Condition: Corroded

The average life of a water heater is 7 to 10 years. This water heater is unusually corroded for a 5 year old tank. Photos show corrosion near the pressure relief valve and on top of the tank. We cannot determine if this corrosion is from the tank itself or because of leaking above the tank. Monitor for leaking and corrosion but expect to replace this tank at any time in the next 5 years.

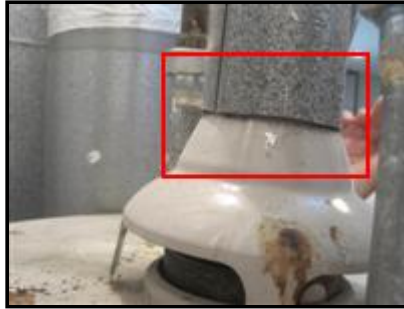
J. Picture 1

Flue Condition: Draft hood not attached properly

The draft hood on the water heater is not properly connected to the flue. See photo. As a result, flue gases can come out of the gap and end up in the home. Consult with a licensed plumber to properly attach the draft hood.

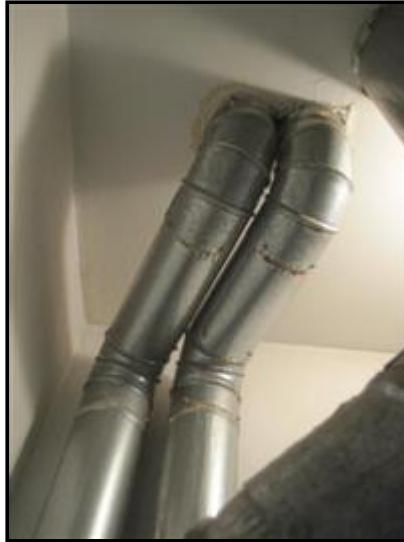
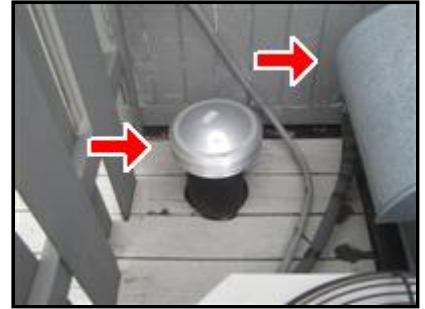
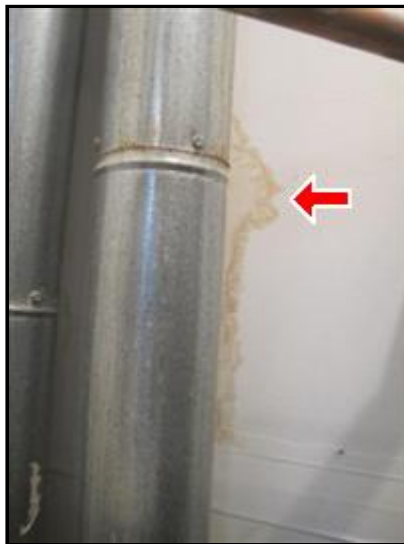
D. Picture 1

Furnace Room: Water damage on ceiling, Water damage on walls

Water damage was noted on the furnace room walls and ceiling. There are 2 pipes that are running up behind the water heater. Photo 1. It appears that these pipes are the bathroom fan vent and the dryer vent from the lower level. These vents exit the roof near the AC condenser. Photo 2. It appears that these pipes are leaking and causing the water damage on the wall/ceiling. This leaking may also be responsible for the corrosion on the water heater. Photo 3.

Further evaluation is needed to verify the purpose of these pipes and then make all necessary repairs to stop the leaking. Consult with a qualified contractor. It is possible that this leaking is caused by poor roof flashings but we could not see the flashings due to the deck. It is also possible that water is getting into the caps on the roof and running down into the vents.

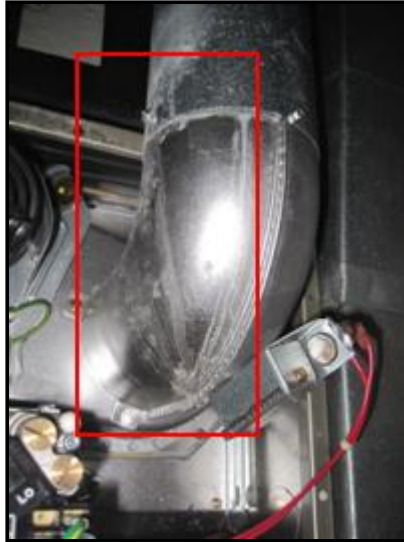
E. Picture 1

Furnace Flue: Metal, Corroded

The furnace flue should be evaluated for proper drafting by a licensed plumber or HVAC contractor. The flue has corrosion on its exterior which is typically a sign of drafting issues.

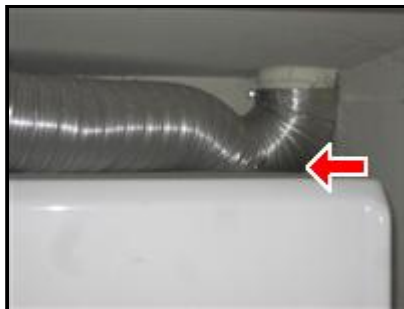
G. Picture 1

🏠 (1) The dryer vent is crushed on top of the machine. Install a new vent to replace the one that is crushed.

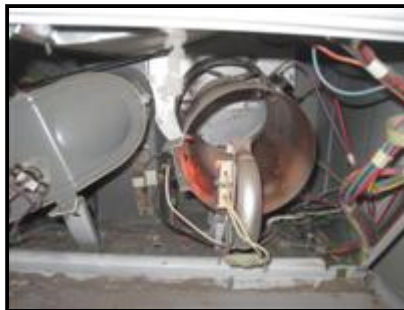
G. Picture 2

🏠 (2) There is a large amount of lint behind the machines and between the machines - see photo. Lint is very combustible and is a common cause of house fires. Please clean all lint from behind the machines.

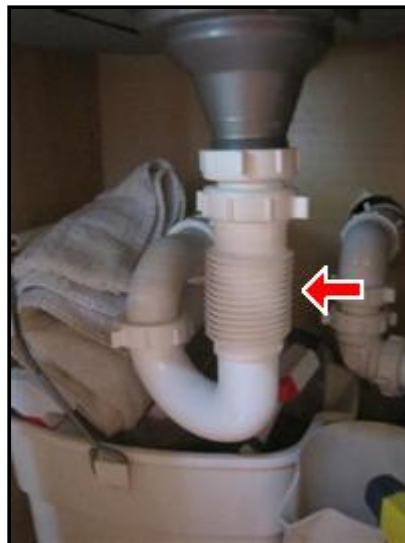
L. Picture 1

Sink Drain: P-trap, PVC, Corrugated PVC

The kitchen drain is corrugated PVC. This type of drain piping can lead to slow drainage. We recommend replacing with solid piping. See photo

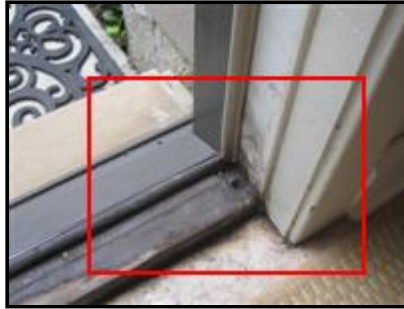
B. Picture 1

There is some very minor water damage in the lower corner of the patio door. See photo. We cannot determine if this is from leaving the door open or if it is because there is a little leaking in the corner. Monitor for leaking and make any necessary repairs to stop leaking.
